NASA TECHNICAL NOTE

NASA TN D-3456

PROJECTILE-IMPACT-INDUCED FRACTURE OF LIQUID-FILLED, FILAMENT-REINFORCED PLASTIC OR ALUMINUM TANKS

by Francis S. Stepka
Lewis Research Center
Cleveland, Ohio

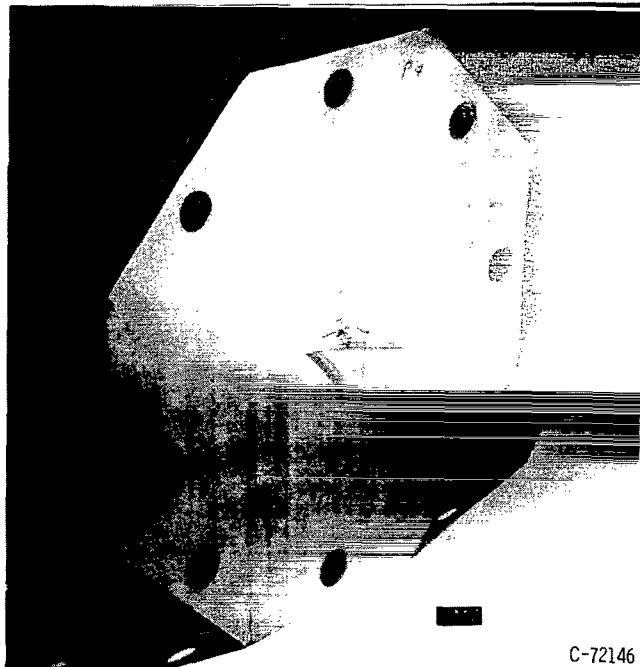
C-72146

Figure 5. - Impact into 0.063-inch-thick Dacron-reinforced urethane specimen wall on liquid-nitrogen-filled tank pressurized to 50 pounds per square inch gage (test 4). Impacting projectile, 7/32-inch-diameter steel sphere; velocity, 5500 feet per second.

Dacron-filament-reinforced urethane specimens: An impact made with a 7/32-inch-diameter steel sphere at a velocity of about 5500 feet per second into a 0.063-inch-thick sheet specimen of Dacron-reinforced urethane pressurized to 50 pounds per square inch gage (wall stress, about 8000 psi) resulted in a puncture and a local delamination of the outer filament layer (test 4), as shown in figure 5. When the initial stress before impact in two other Dacron-reinforced specimens (tests 5 and 6) was increased to about 12 800 pounds per square inch (by a liquid pressure of 100 psig), impact by a projectile resulted in catastrophic fracturing of the specimens, as shown in figure 6 for test 5.

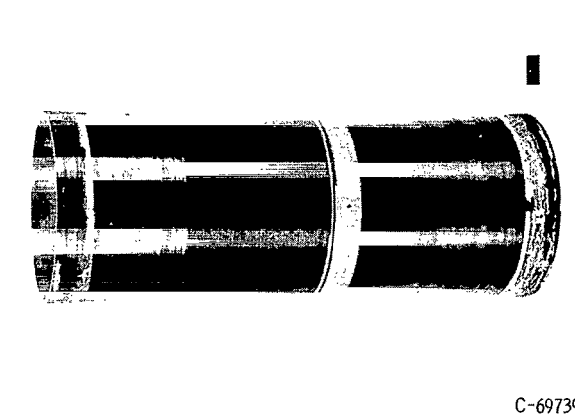
(a) 0.040-Inch-thick, 7.5-inch-diameter tank pressurized to 80 per cent of ultimate stress before impact (test 15).

(b) 0.040-Inch-thick, 7.5-inch-diameter tank pressurized to 50 per cent of ultimate stress before impact (test 17).

(c) 0.040-Inch-thick, 7.5-inch-diameter tank pressurized to 38 per cent of ultimate stress before impact (test 19).

(d) 0.033-Inch-thick, 7.5-inch-diameter tank pressurized to 40 per cent of ultimate stress before impact (test 22).

Figure 10. - Results of impact into glass-reinforced epoxy tanks filled with liquid nitrogen. Impacting projectile, 7/32-inch-diameter steel sphere; velocity, 5500 feet per second.

wall-stress - ultimate-strength ratios of 0.8, 0.6, 0.5, and 0.45 (tests 15 to 18), resulted in fracture of the walls in respectively decreasing extent. The results of impact into the tanks with the wall-stress - ultimate-strength ratios of 0.8 and 0.5 (stress of 80 and 50 percent of ultimate stress) are shown in figures 10(a) and (b), respectively. When the internal pressure in the tanks of this group was reduced to produce a ratio of wall stress to ultimate strength of 0.35 and 0.38 prior to impact (tests 19 and 20), only a hole with local delamination of the outer filament layer was obtained as a result of impact. The results of impact for the tank with the ratio of wall stress to ultimate strength of 0.38 and shown in figure 10(c). The results obtained with the first group of tanks indicated that the critical ratio of wall stress to ultimate strength prior to impact for fracture at the imposed impact conditions was between 0.38 and 0.45

The tank with the 0.040-inch-thick wall in the second group was pressurized prior to impact to produce a wall-stress - ultimate-strength ratio of 0.5 (test 21). Although catastrophic fracture of the tank was expected, based on the results of the first group of tanks tested, only a hole was obtained with delamination of the outer filament layer around the tank in the vicinity of the puncture. Although one data point is not sufficient for a conclusion, the result obtained might imply that the winding of the filaments in layers 90° to each other provides a better resistance to fracture from impulsive loading compared with a helically wound glass-filament-reinforced epoxy tank. Impact into the 0.033-inch-thick wall tank at a wall-stress -

ultimate-strength ratio of 0.4 (test 22) also resulted in only a hole and delamination of the outer layer of filaments around the tank (fig. 10(d)). Impact into the 0.012-inch-thick wall tank with an initial wall-stress - ultimate-strength ratio of 0.2 (test 23) resulted in catastrophic bursting of the wall. This result, obtained with the relatively low-stressed thin-walled tank, indicates that as the tank walls become thinner (1) the transient stresses produced in the wall by the pressure pulse generated in the contained liquid by the decelerating projectile become the dominant factor influencing the fracturing of the tank wall and (2) fracture becomes less dependent on the initial static stress level in the walls.
